Manhole Inspection Summary

Manhole # S19G__050MH

Insp Date: **10/1/07 8:42 AM**

Location Address: **2101 FAYETTE-ALLEY-FAIRMOUNT** Cross Street: **PULASKI ST**

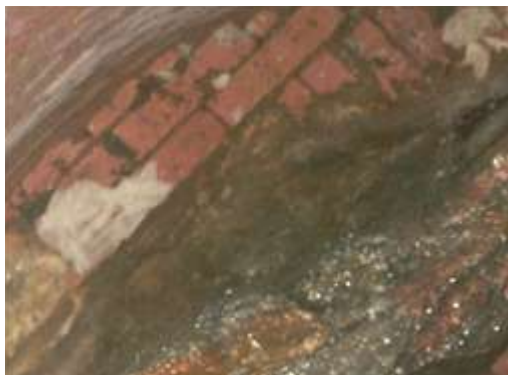
Defect 4

Bench ☒ Exists Material: **Brick** ☐ Parged
Condition: ☐ Sound ☐ Cracked ☐ Root Intrusion ☒ **Deteriorated** ☐ Leaks ☐ Debris

BENCH DETERIORATION

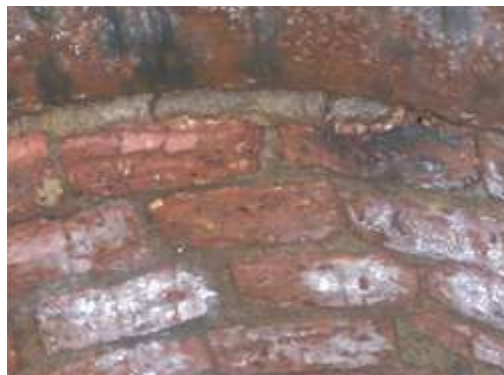
Defect 3

Corbel Material: **Brick** ☐ Parged Type: **Concentric/Eccentric**
Condition: ☐ Sound ☐ Cracked ☐ Root Intrusion ☐ Loose Brick ☒ **Deteriorated**
Infiltration: ☒ None ☐ Joint ☐ Cracks ☐ Mortar ☐ Roots ☐ Wall

CORBEL DETERIORATION

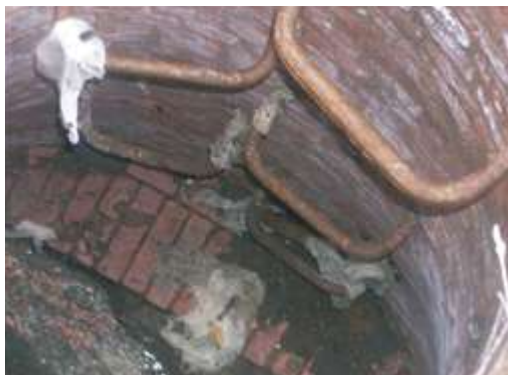
Defect 2

Steps Count: **5** Missing: **0** ☒ **Corroded**

Surcharge ☒ **Evidence Of Surcharge** Depth: **5** (ft.) ☐ Active Surcharge Present

CORRODED STEPS AND SURCHARGE EVIDENCE

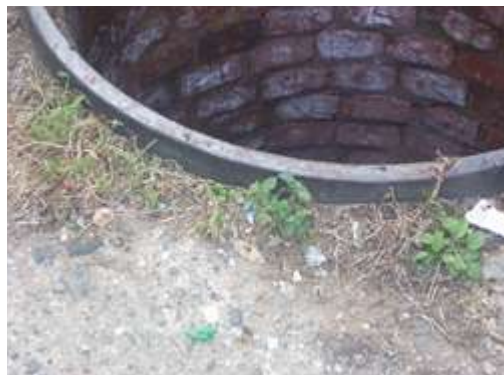
Defect 1

Cover Shape: **Circular** Diameter: **24** (in.) Length: (in.) Dist A/B Grade: **1** (in.)
Type: **Sanitary** Condition: **Sound** Cover Material: **Cast Iron**
Properties: ☐ Bolted ☐ Vented ☐ Water Tight ☐ Water Tight Insert

GRADE ADJ

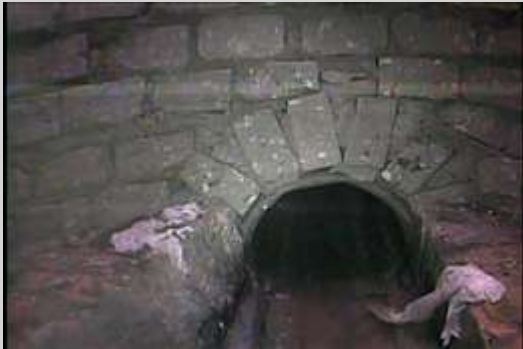
12 O'Clock Outflow

8 in. Circular Gravity Sewer
Pipe Out @ 12 O'Clock

Pipe Height: **8.4** (in.) Rod and Bar (Angled)
Pipe Material: **Clay** ☐ Pipe Lined
Invert Depth: **8.74** (ft.) Flow Characteristics: **Slow**
Deposits: ☒ None ☐ Mud ☐ Sludge ☐ Debris ☐ Grease
Silt Depth: (in.) Deposits Extent:
Infiltration: **None** Pipe Seal Cond: **Sound**

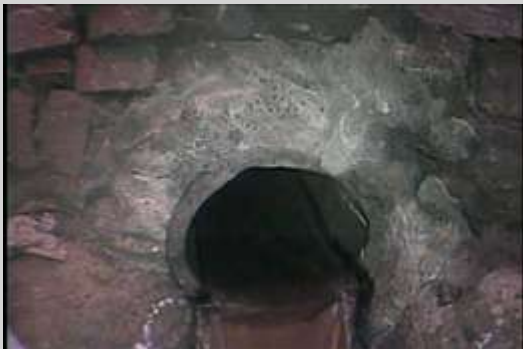
6 O'Clock Inflow

8 in. Circular Gravity Sewer
Pipe In @ 6 O'Clock

Pipe Height: **8.4** (in.) Rod and Bar (Angled)
Pipe Material: **Clay** ☐ Pipe Lined
Invert Depth: **8.41** (ft.) Flow Characteristics: **Slow**
Deposits: ☒ None ☐ Mud ☐ Sludge ☐ Debris ☐ Grease
Silt Depth: (in.) Deposits Extent:
Infiltration: **None** Pipe Seal Cond: **Sound**
